National Register of Historic Places
Continuation Sheet

Bates, John M. and Elizabeth, House
No. 4

Clackamas Co., OR

This is a Petition to delist the Bates House, No. 4 located at 4101 SW Southshore Drive, Lake Oswego, Oregon from the National Register of Historic Places. The residence is a single-story house on a daylight basement. It was designed in the 1950s and completed in 1954. The residence was listed on the register due to its architecture and engineering, including, closets, cabinetry, moldings and brass fittings. However, since that listing in 1990, those qualities (and details) have long ceased to exist.

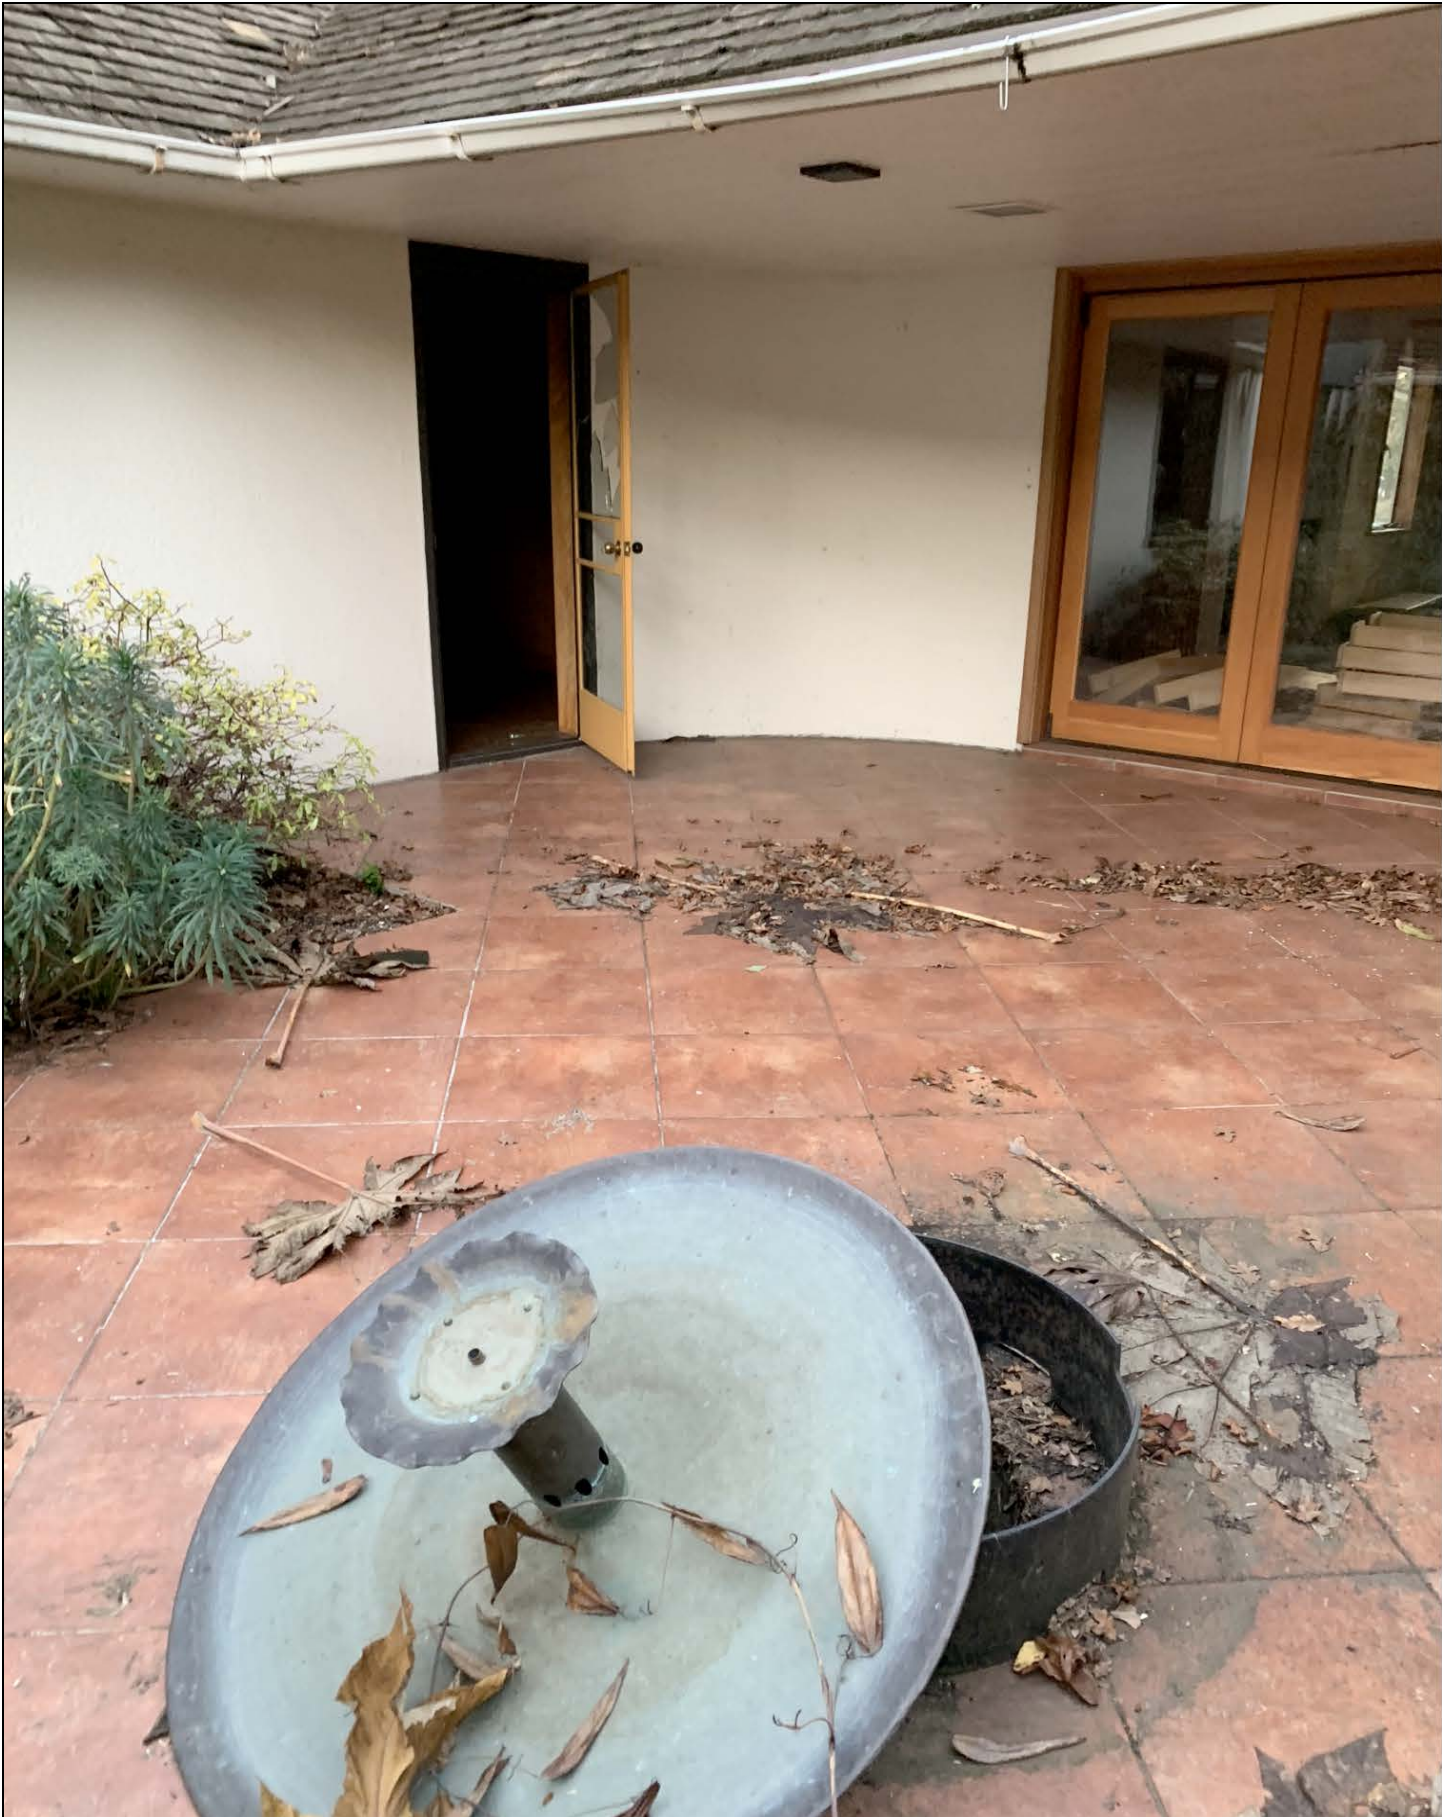
Photo 2 of 15: Courtyard and collapsing roof

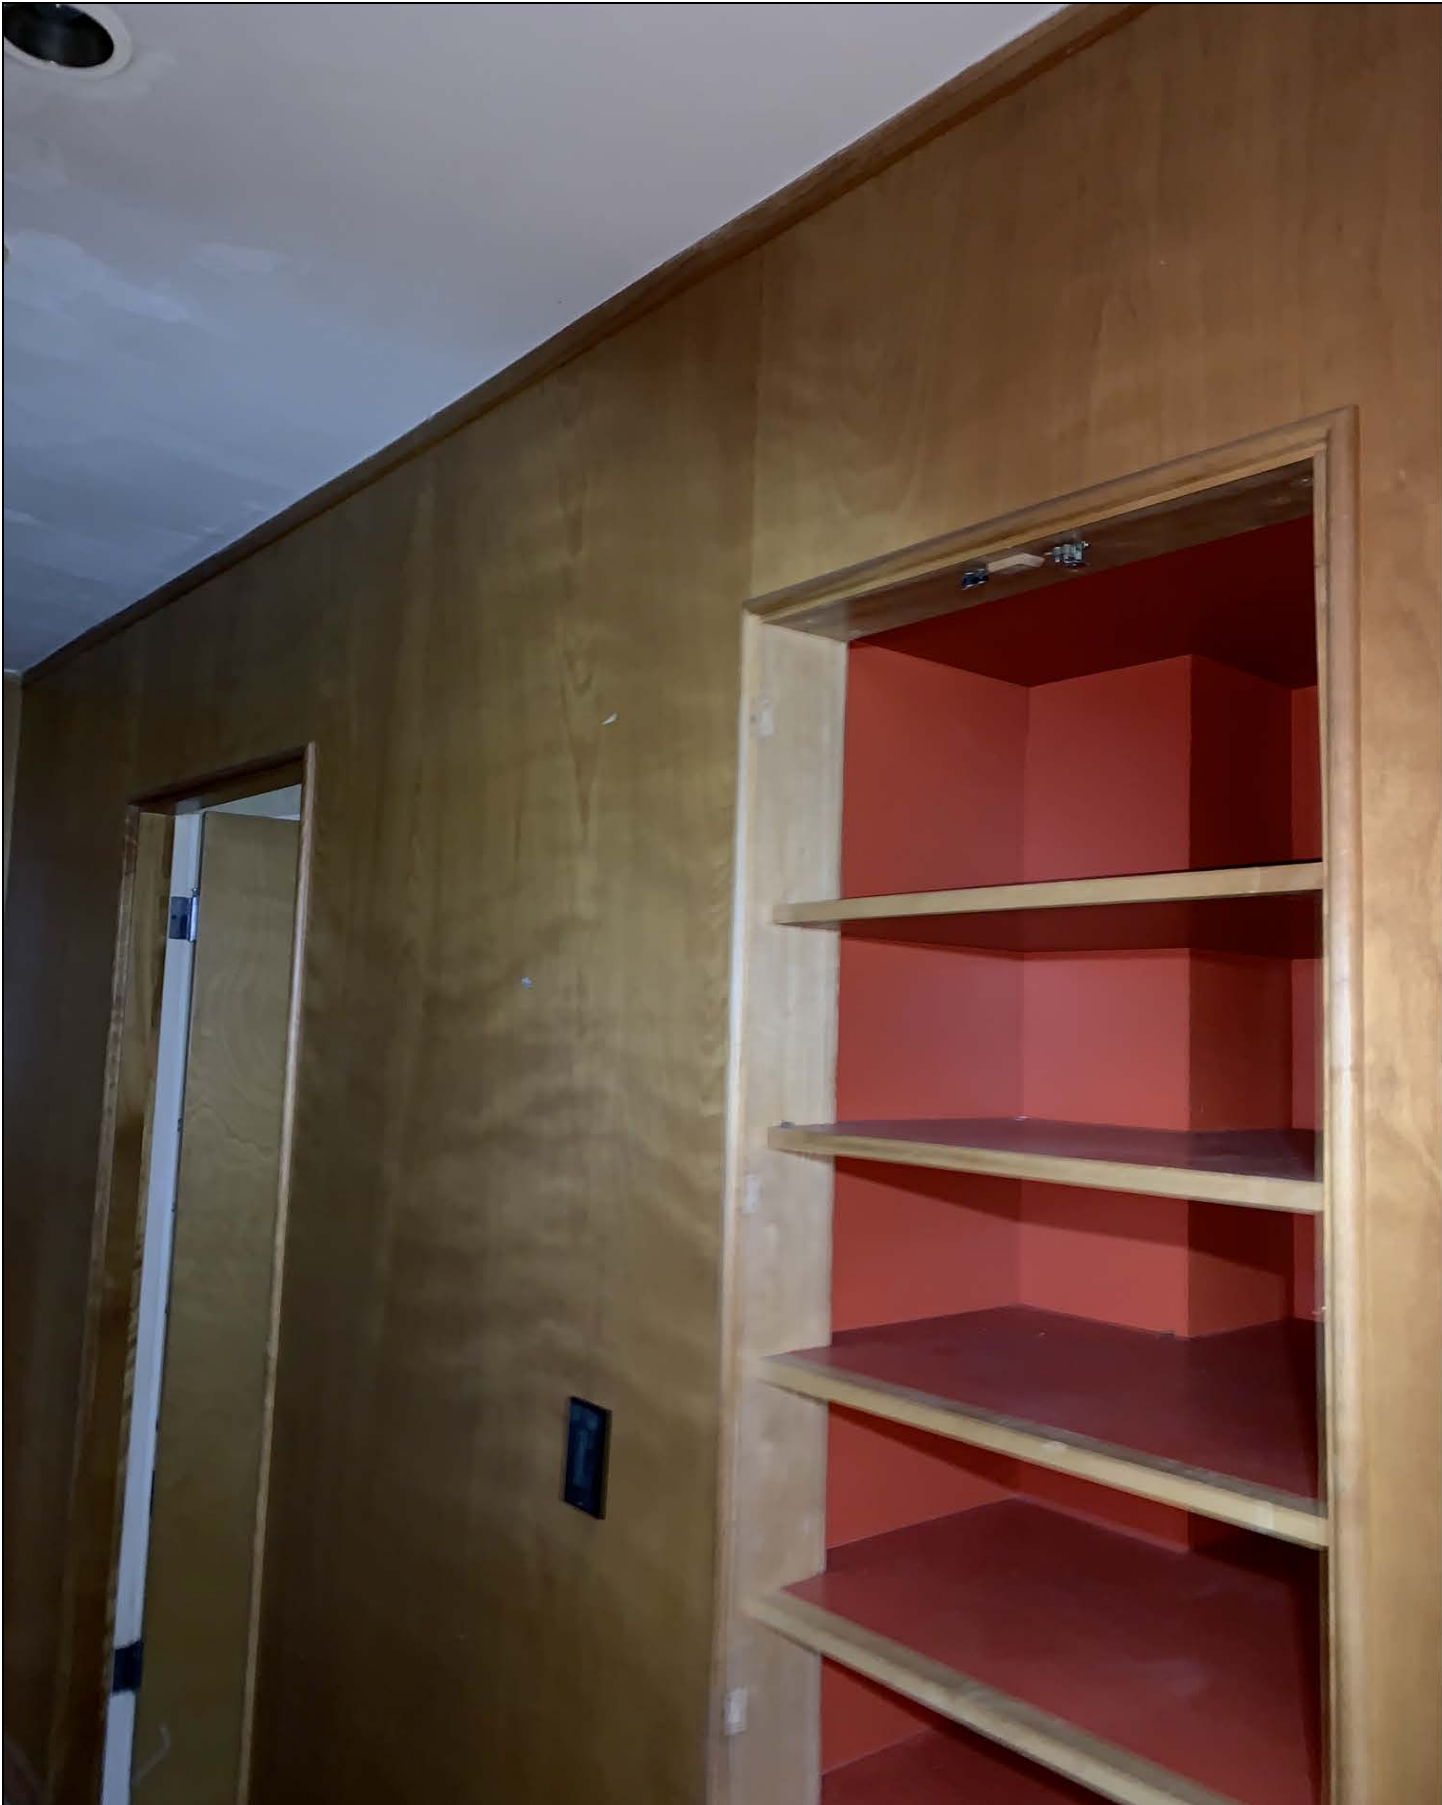
Photo 3 of 15: Stripped cabinetry

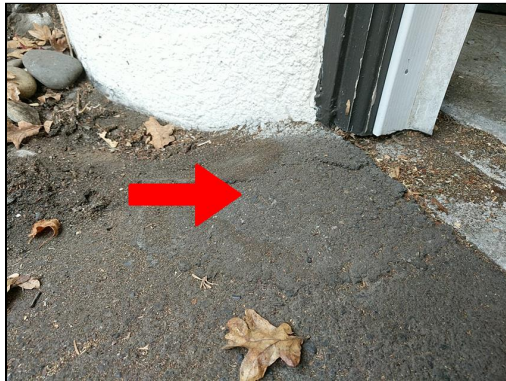
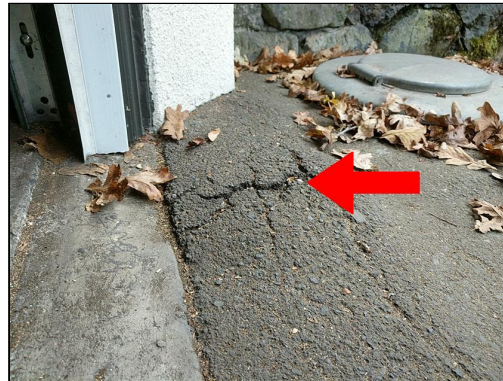
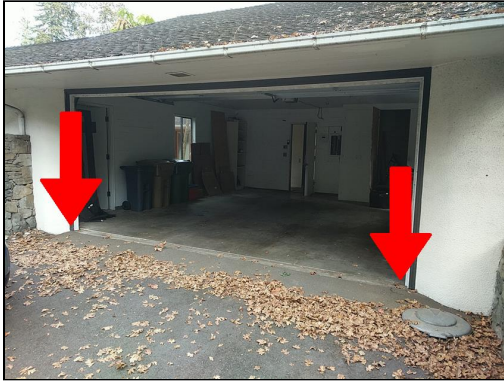
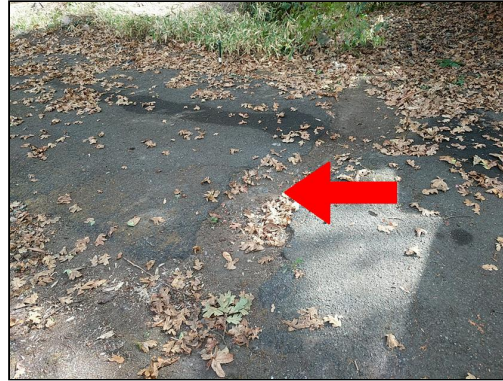
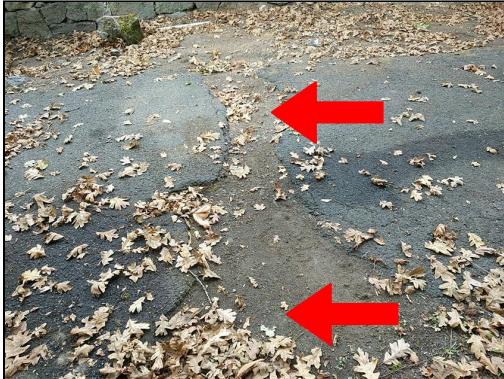
1.0 Driveway and side driveway had multiple areas of damage which may indicate heaving soil at these areas. Recommend further evaluation and repairs as necessary by a qualified soil engineer.

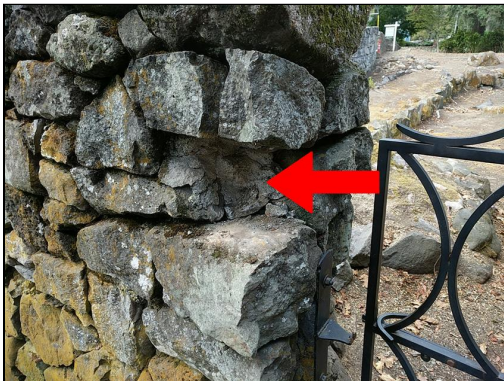
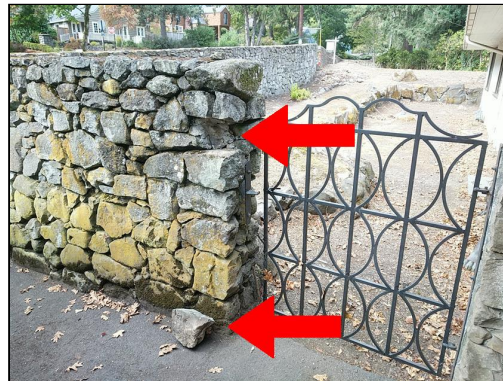
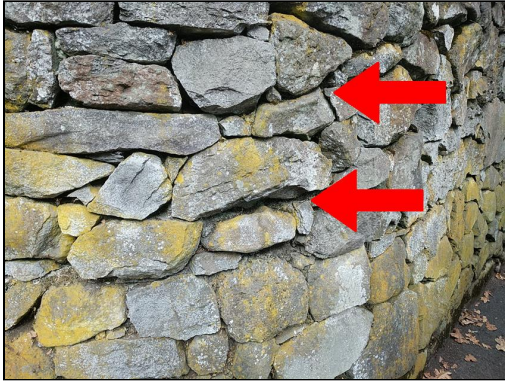
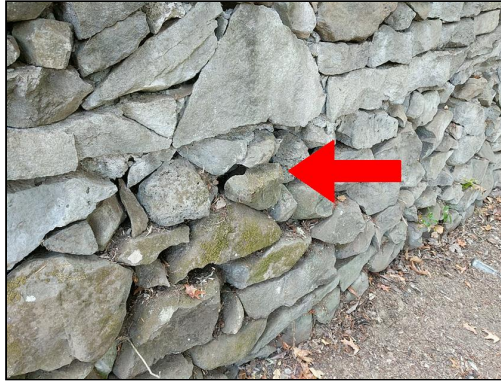
1.1 (1) Deteriorated mortar and loose rocks were visible at multiple areas of the retaining wall and are a safety hazard. Recommend further evaluation and stabilization as needed by a qualified masonry contractor.

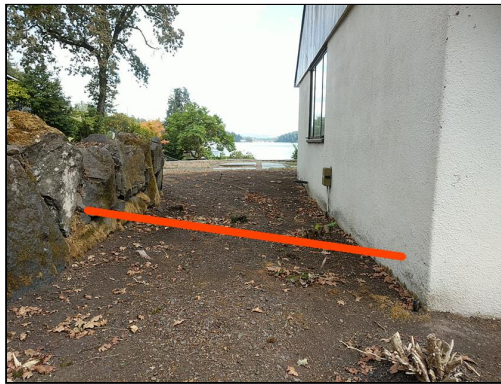
1.1 (2) There is a negative slope in the grading at the front of the home and left side of the home. This area does not appear to properly drain water away from the home and may need correction to the grading. A properly graded site should slope away from the home at least 6 inches within 10 feet of the foundation to help direct water away from the home. When it is not possible to achieve proper grading in this manner other measures may be used to promote proper drainage such as swales or landscaping drains. Recommend further evaluation and correction as needed by a qualified landscaping contractor.

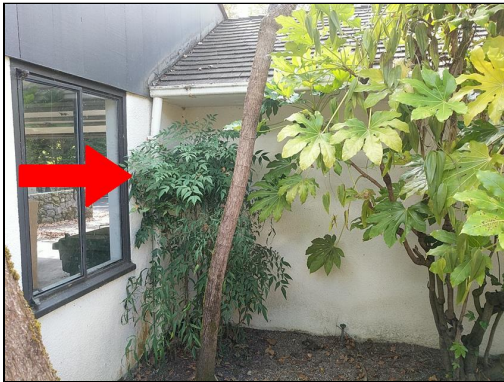
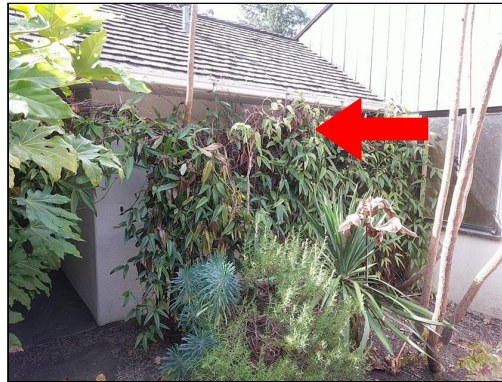
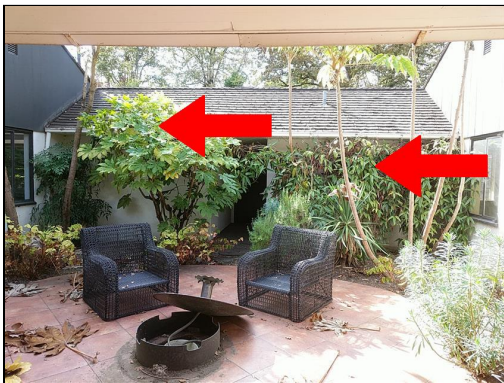
1.1 (3) Vegetation was in contact with the roof and wall cladding at one or more areas around the home's exterior. This will hold moisture against the house and may result in moisture related damage to the wall cladding and structural components of the home. Vegetation should be trimmed and maintained to a minimum of 12-16 inches from the wall cladding (trees to 10 feet minimum) to help prevent moisture related damage and to discourage insect intrusion. Recommend correction and maintenance as needed by a qualified landscaping contractor.

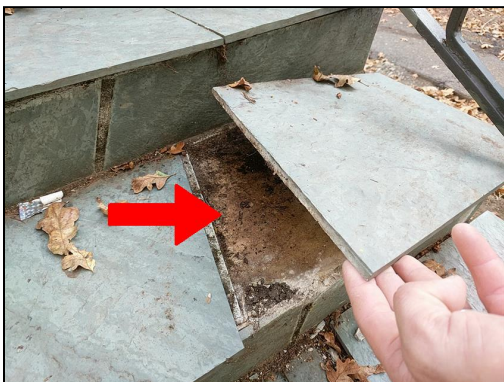
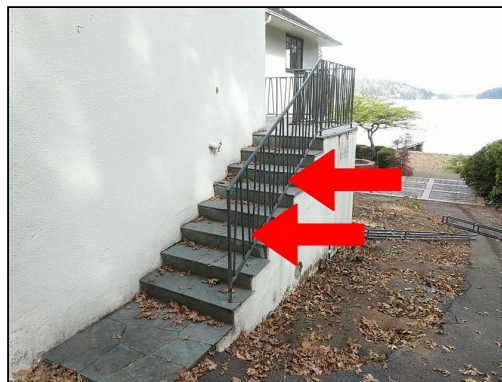
1.2 (1) Back porch tiles were loose at multiple areas due to moisture exposure and water related damage. Loose tiles are a safety and fall hazard. Recommend further evaluation and correction as needed by a qualified contractor.

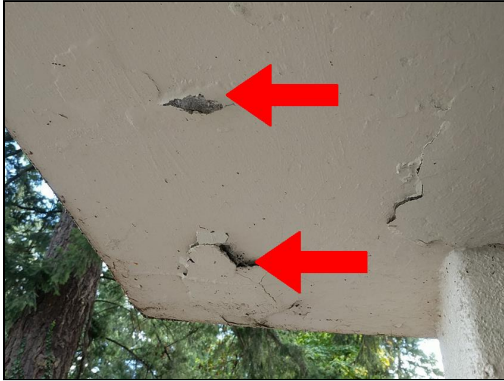
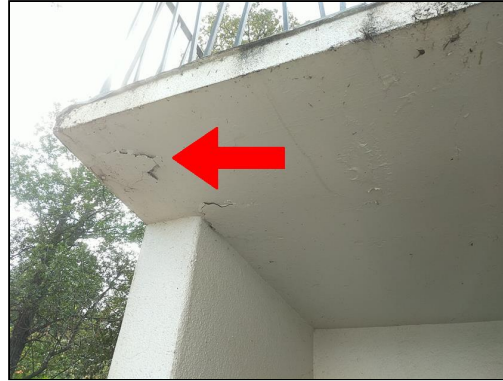
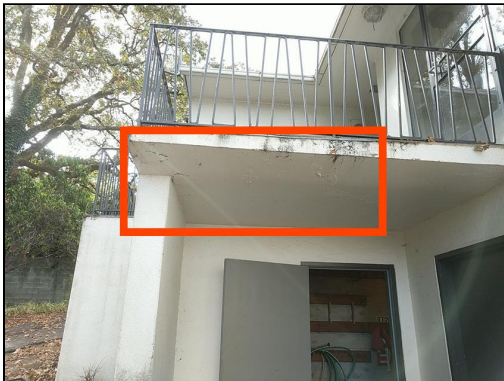
1.2 (2) Underside of the back porch covering had deteriorated and scaling concrete from excessive moisture contact. Recommend repairs as needed by a qualified masonry contractor.

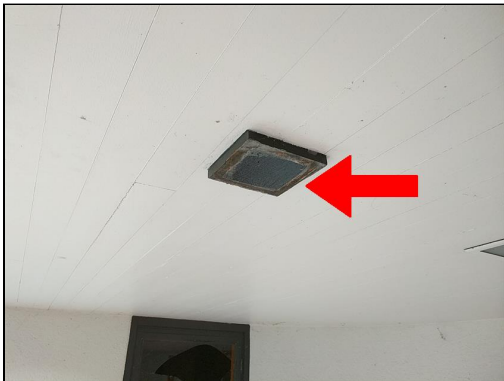
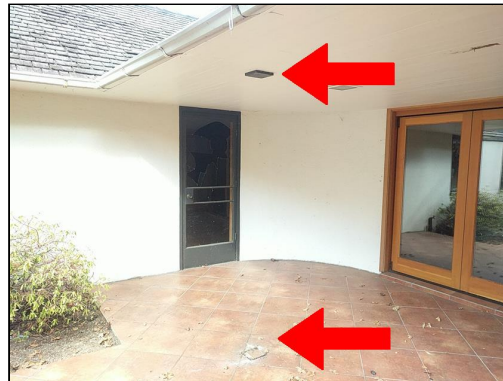
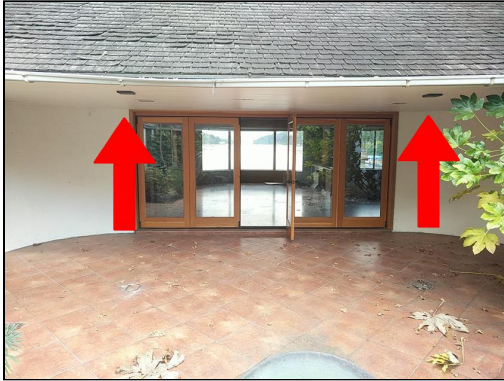
1.2 (3) Structural support posts at the interior patio had been removed which has compromised the structural integrity of the patio. Recommend further evaluation and repairs as needed by a qualified structural engineer.

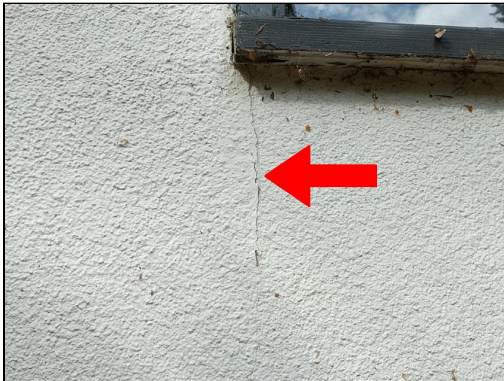
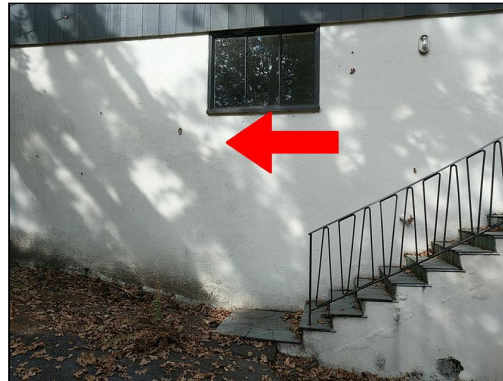
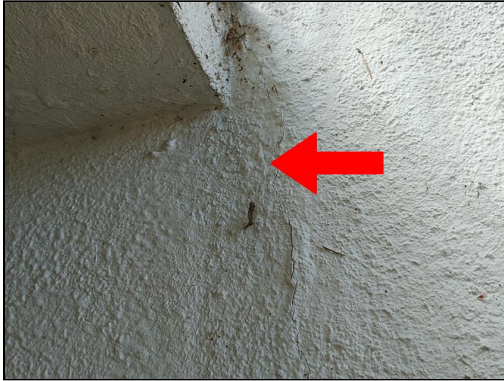
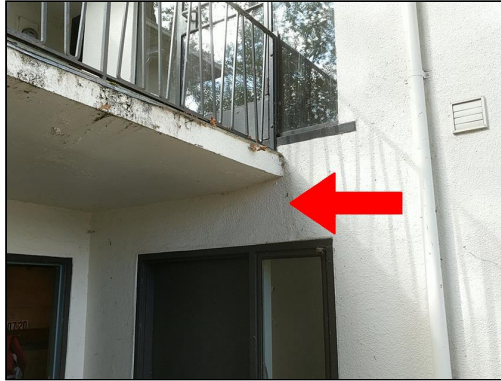
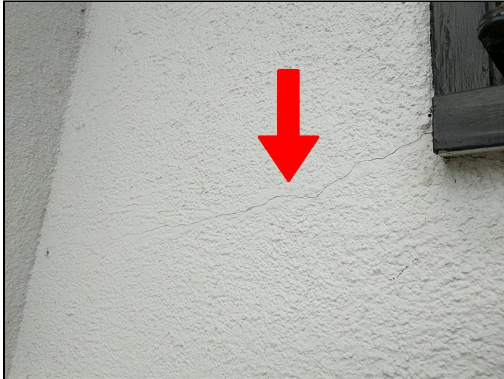
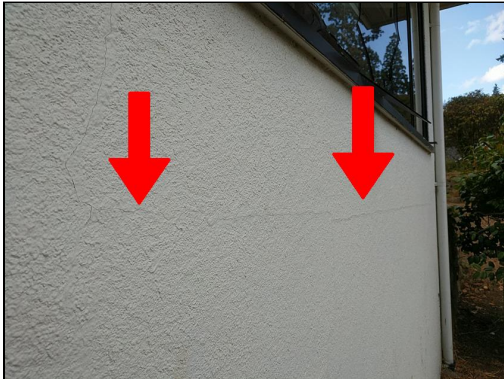
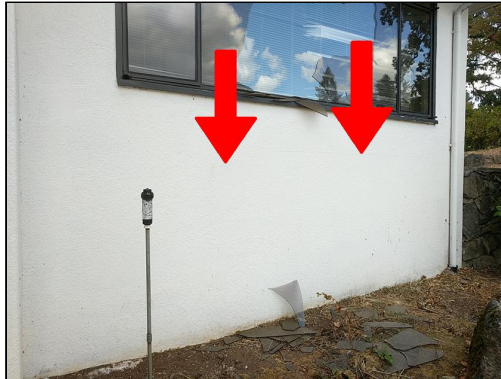
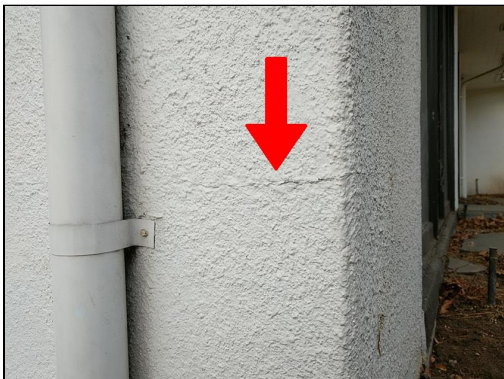
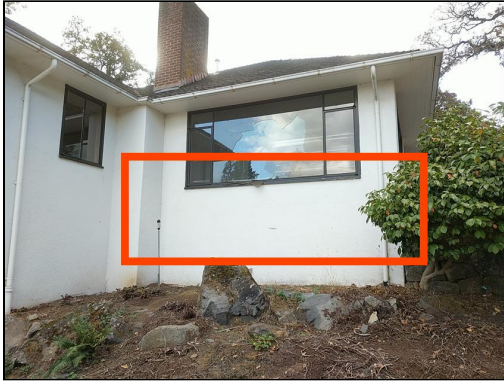
1.3 (1) Diagonal and horizontal hairline cracks in the stucco visible at multiple areas may be an indication of excessive movement and settling of home. Recommend further evaluation and repairs as needed by a qualified contractor.

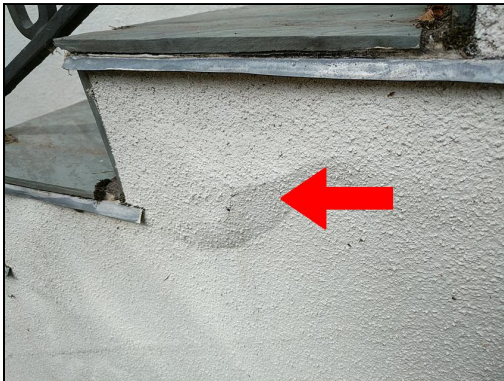
1.3 (2) Stucco at the back porch was peeling and discolored with various forms of fungus and microbial growth from water intrusion into the porch structure. Framing members were not visible and may have additional damage not able to be evaluated. Recommend further evaluation and repairs as needed by a qualified contractor.

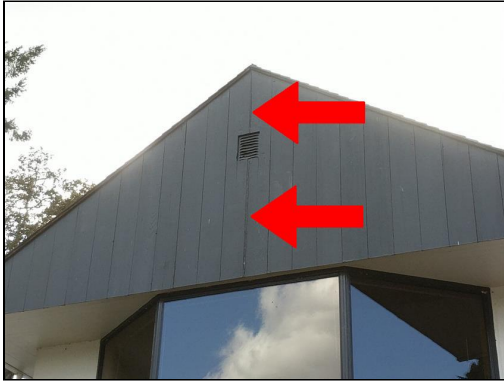
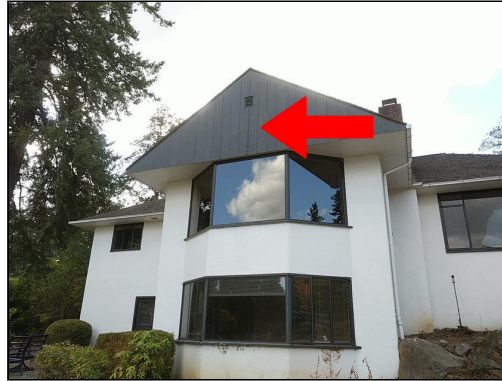
1.3 (3) Cedar siding at the south side of the home was damaged and appeared to be deteriorated from weather exposure. Limited access due to height restrictions limited full evaluation of this area. Recommend further evaluation and repairs as needed by a qualified contractor.

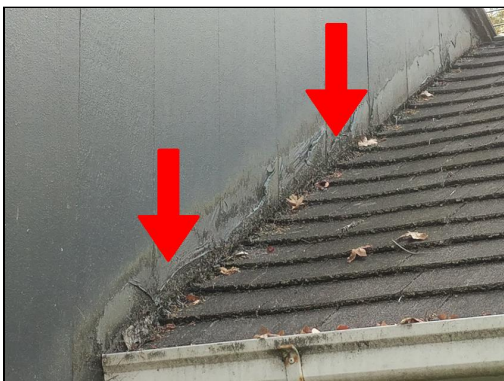
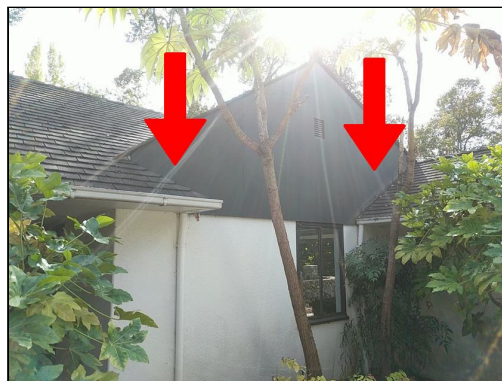
1.3 (4) Wall cladding at the roof gables had inadequate clearance above the roof covering material. At both headwalls and sidewalls, a gap of at least 1½ inches between the bottom of the exterior wall-covering material and the top of the roof-covering material should be provided. Without a gap, the exterior wall covering will wick up moisture from the roof which will lead to moisture related damage and deterioration. Recommend correction by a qualified roofing contractor.

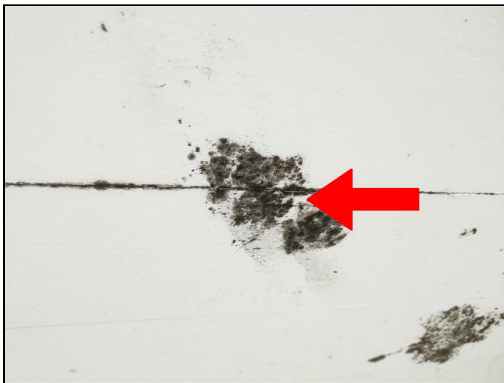
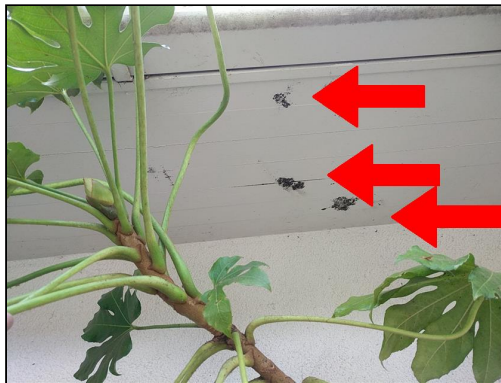
1.4 Microbial growth was visible under the atrium eaves at multiple areas. This is likely the result of vegetation holding moisture against the eaves. The type of growth or extent of damage was not determined. Growth may extend behind the eaves and will require destructive testing and laboratory analysis to determine the amount and type(s) of growth present. Recommend further evaluation and treatment for removal by a qualified mold remediation expert.

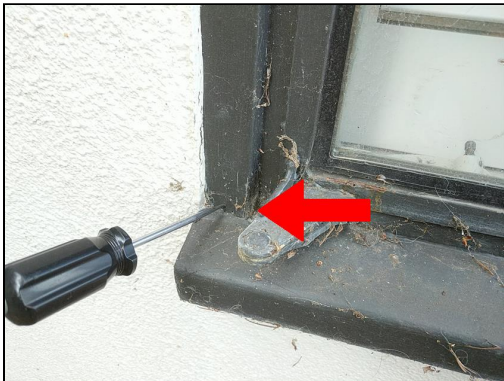
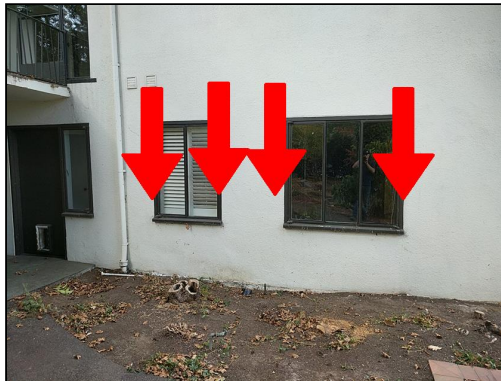
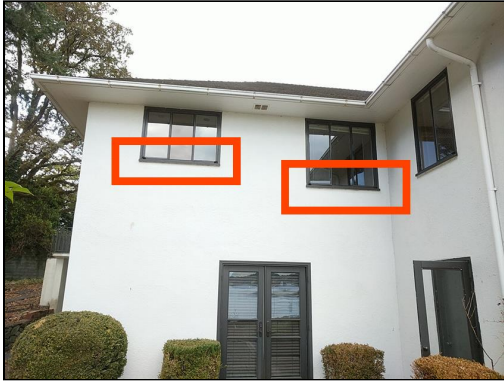
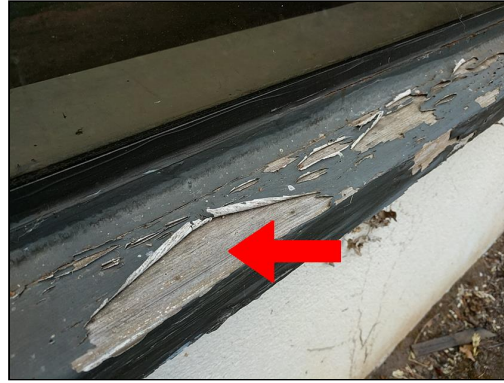
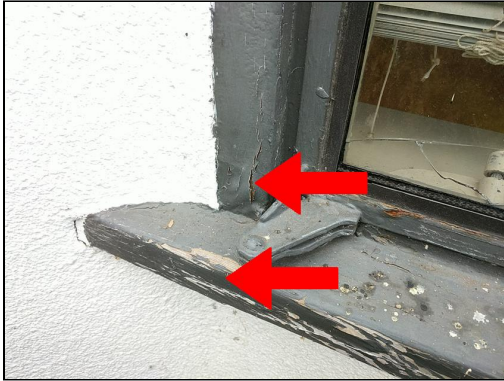
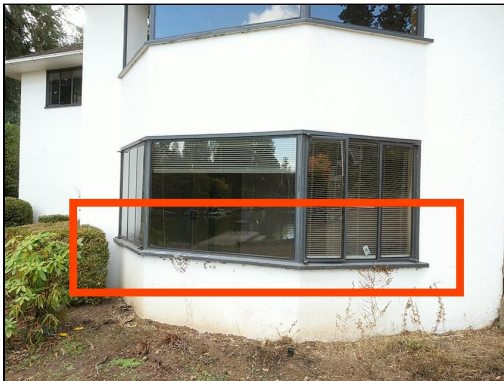
1.5 (1) Window frames had varying levels of wood rot visible. Recommend further evaluation and repairs as needed by a qualified contractor.

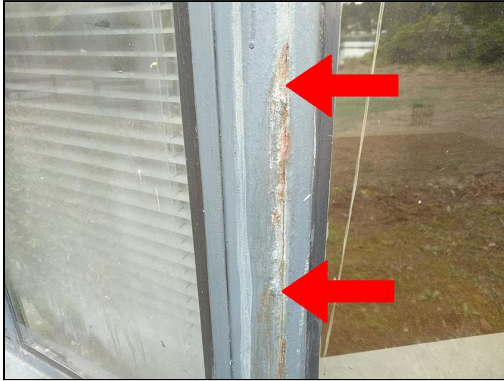
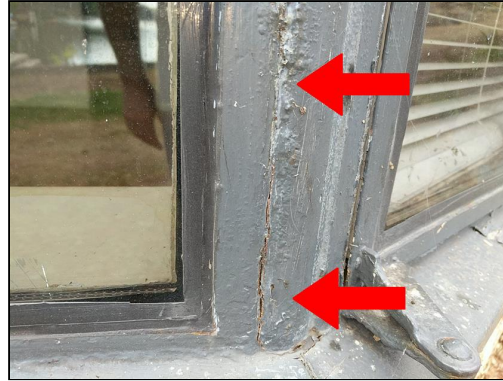
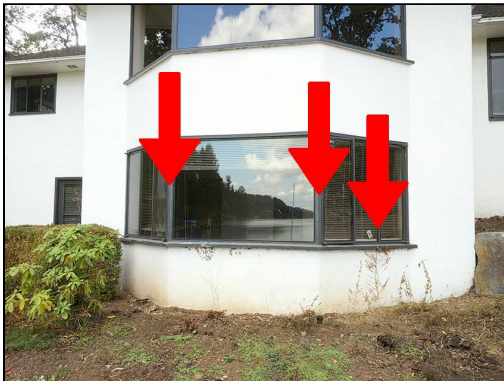
1.5 (2) The basement level bay window steel support columns were rusted and may be structurally compromised. Recommend further evaluation and repairs as needed by a qualified contractor.

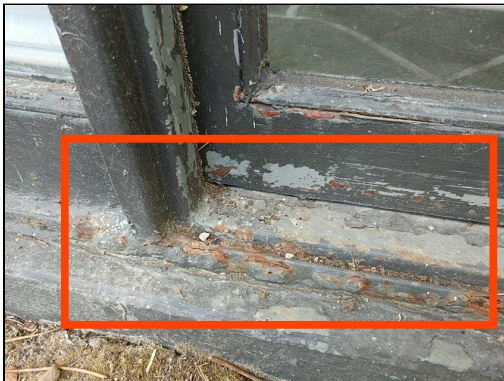
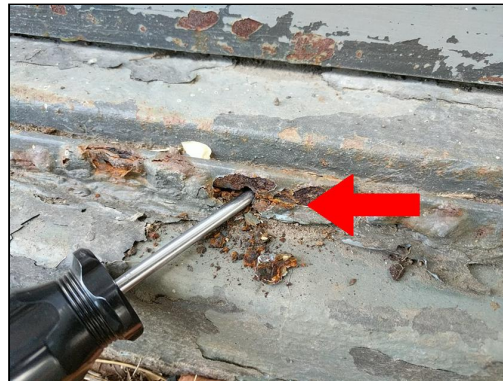
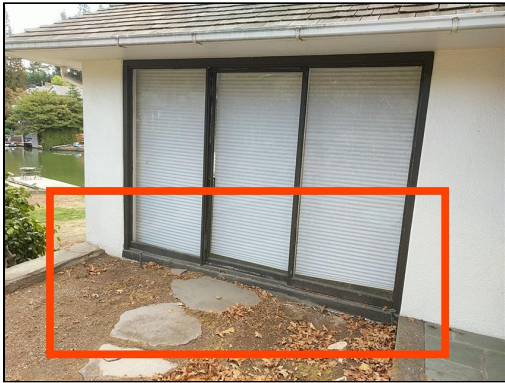
1.6 (1) Steel sliding patio doors and frames at the east side of the home were severely rusted and will likely need replacement. Recommend further evaluation and repairs as needed by a qualified contractor.

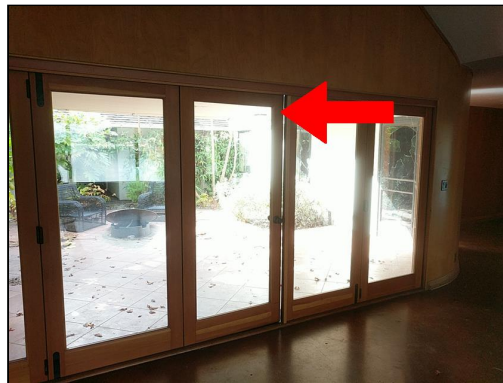
1.6 (2) Atrium doors were binding and would not fully close. This may be related to movement at this area from removal of posts (see notes at item 1.2). Recommend further evaluation and repairs as needed by a qualified contractor.

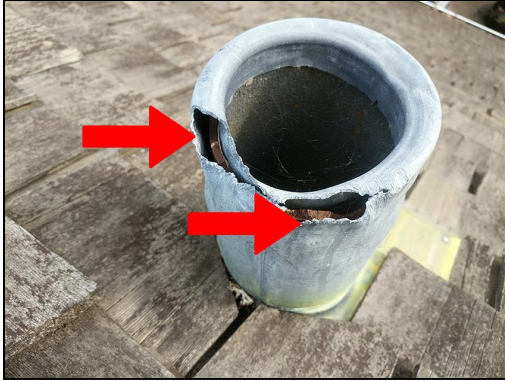
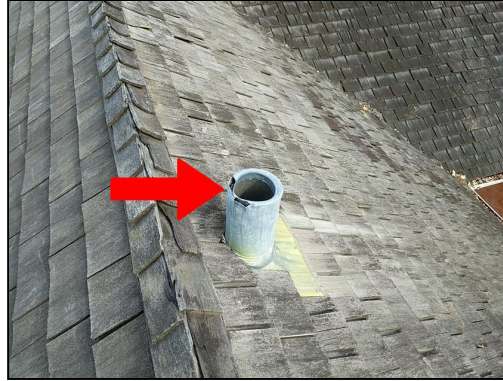
2.2 Lead flashing at one or more roof penetrations was deteriorated and will leak. Recommend repairs by a qualified roofing contractor.

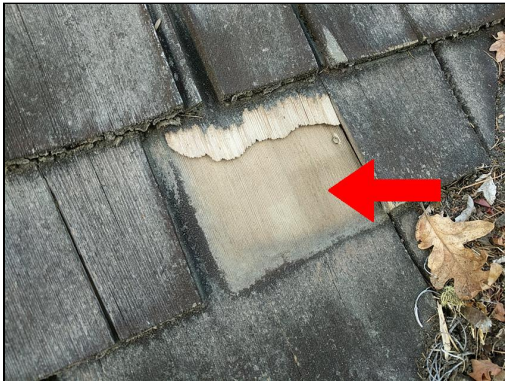
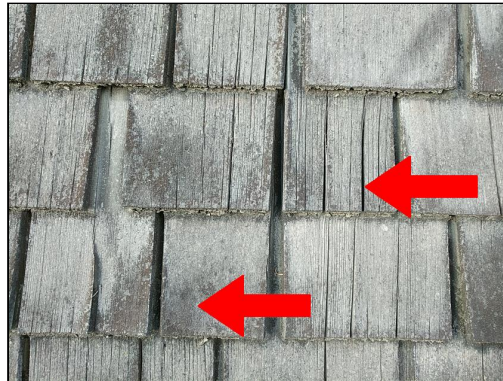
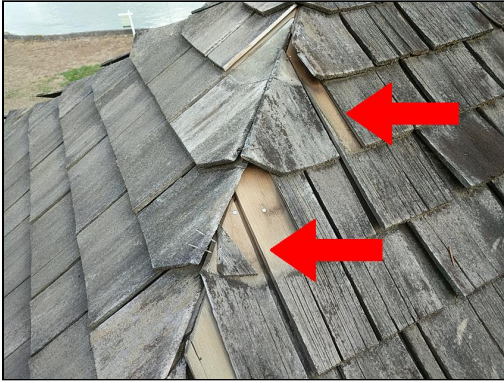
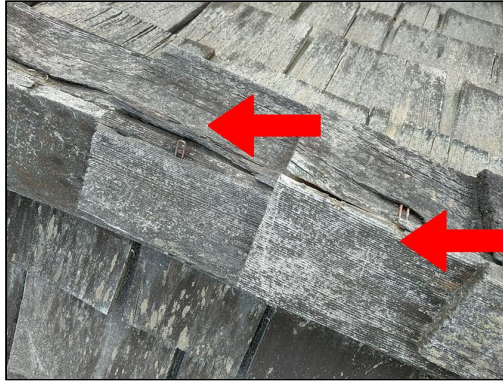
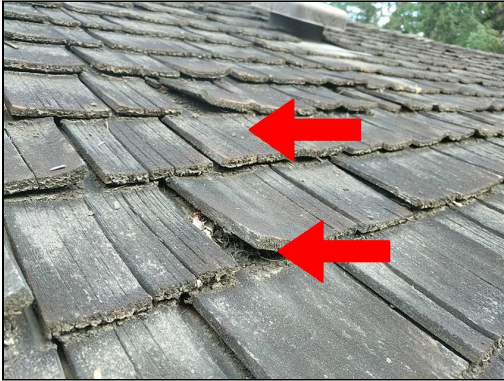
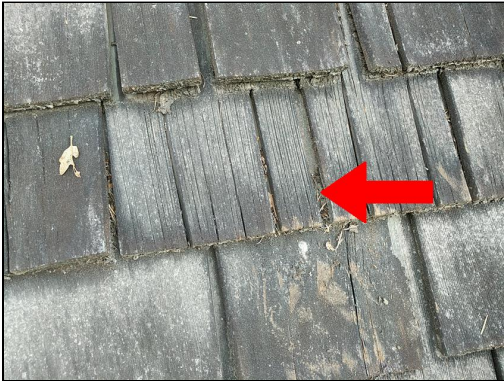
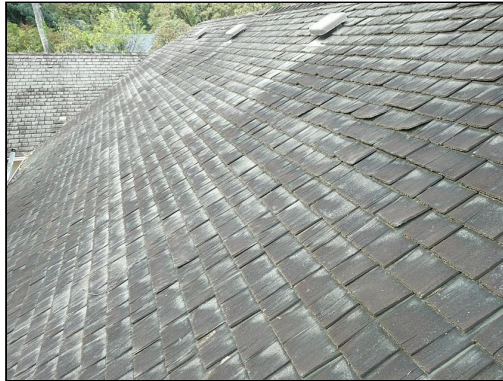
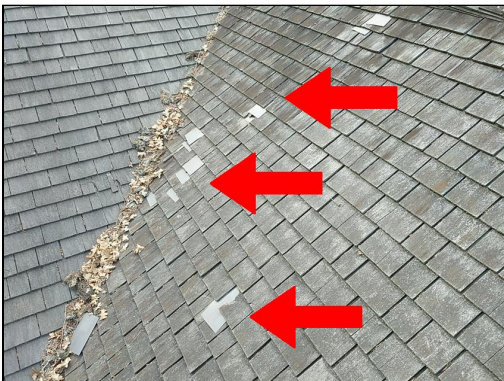
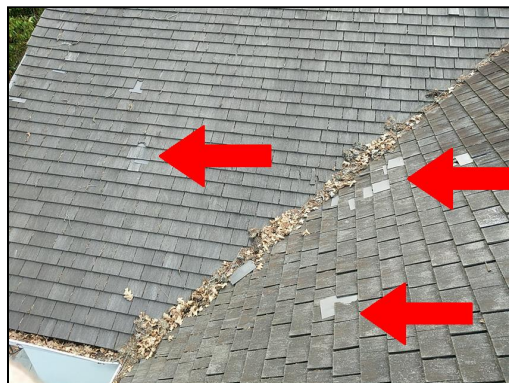
2.10 The wood shingle roof-covering material was at the end of its useful life. It was severely deteriorated, with many split, broken and missing shingles, advanced decay of shingle butts, and areas in which shingles were eroded through. Recommend consulting with a qualified roofing contractor to discuss options and costs for replacement.

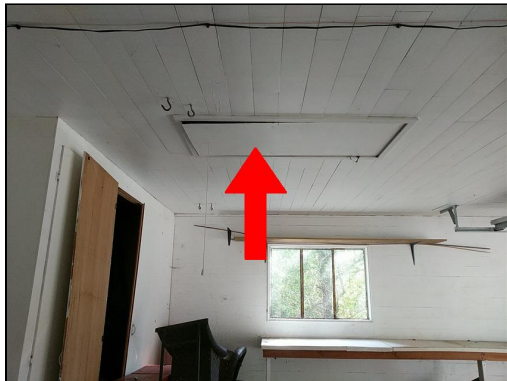
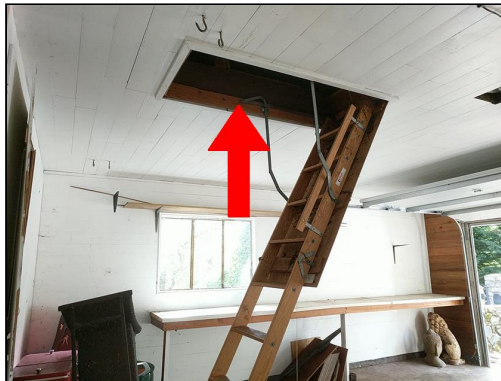
3.0 The attic was accessed by a ceiling-installed pull-down ladder in the garage.

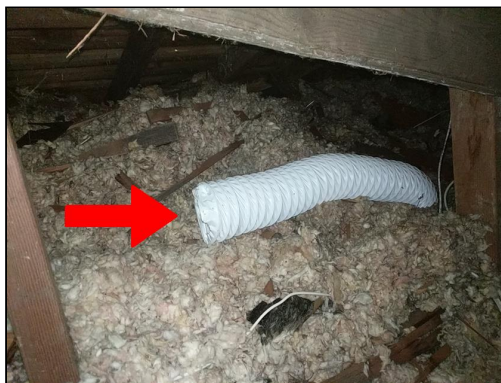
3.7 A bathroom exhaust vent terminated in the attic instead of at the home exterior. This can cause excessively high moisture vapor levels in the attic with the potential to damage home materials and be a source of microbial growth. Recommend correction by a qualified contractor.

The duct from the range hood or other exhaust system did not properly or fully direct exhaust to the exterior. This may result in moisture related damage to attic materials from the formation of condensation and is a potential source of microbial growth. Recommend correction by a qualified contractor so that the duct properly terminates to the exterior of the home.

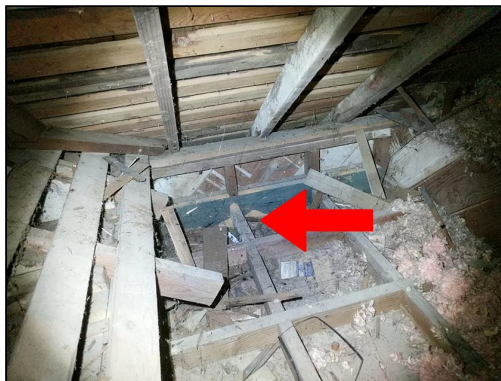
3.8 (1) Damage from wood destroying organisms (WDO's) was visible on the roof framing at one or more areas in the attic. What appeared to be fresh frass (powdery refuse from WDO activity) was visible indicating possible active WDO nesting exists. Recommend further evaluation by a qualified pest control expert and treatment for removal as advised.

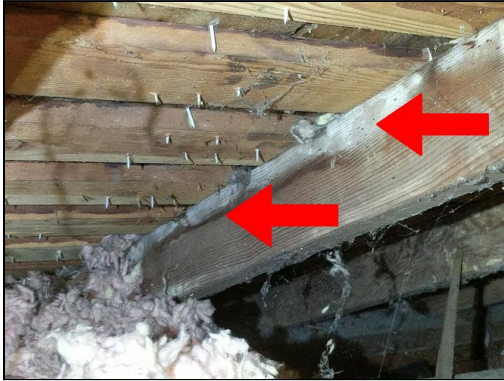
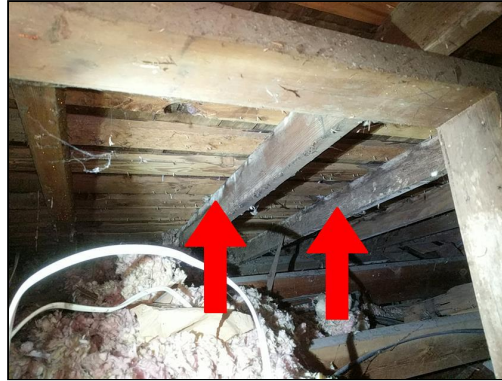
3.8 (2) Stains from roof leakage were visible on roof rafters at multiple areas. Recommend repairs or roof replacement by a qualified roofing contractor.

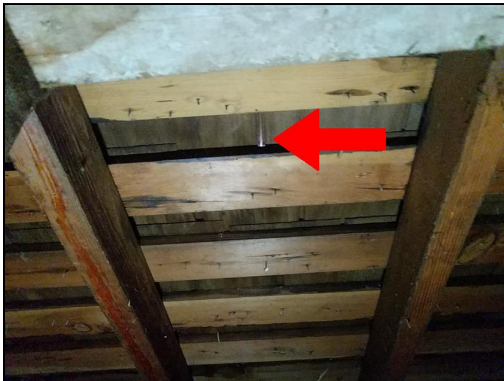
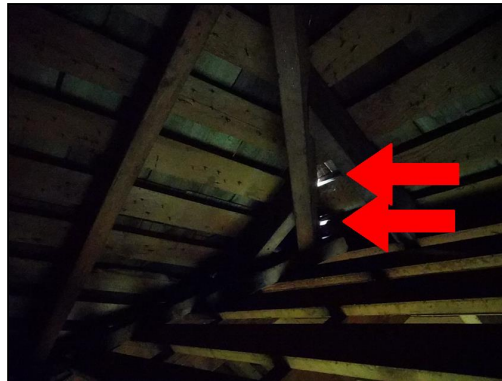
3.8 (3) Multiple areas gaps between wood shingles were visible which will leak during rain activity. Recommend repairs or roof replacement.

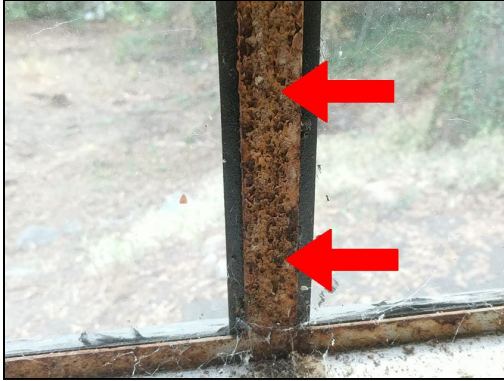
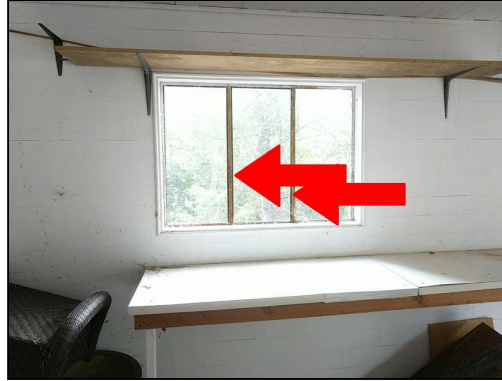
4.6 Garage windows had significant deterioration from rust. Recommend further evaluation and repairs as needed by a qualified contractor.

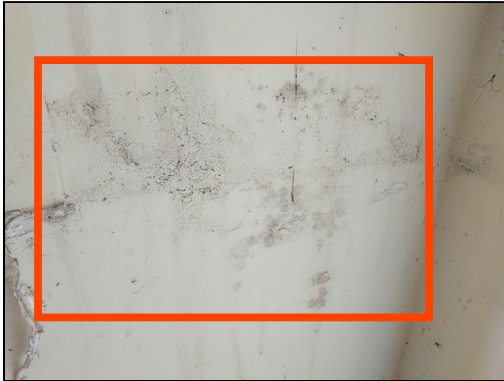
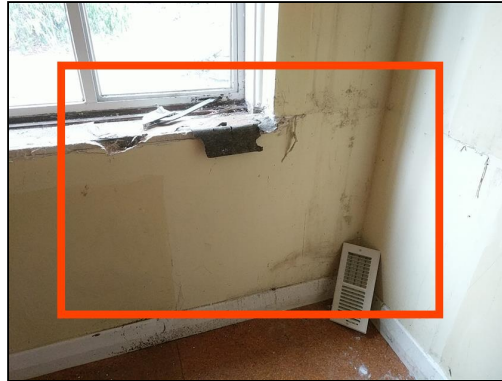
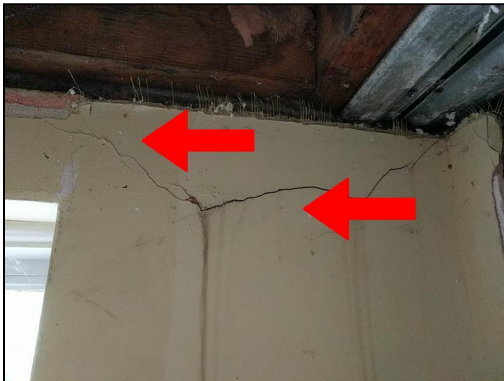
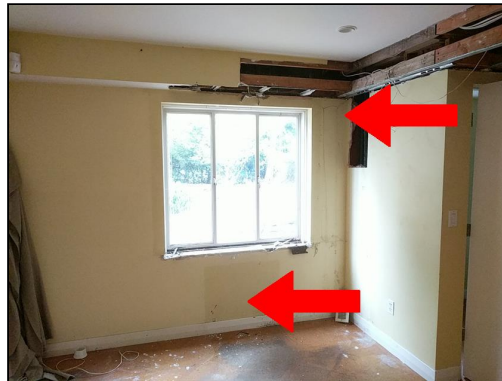
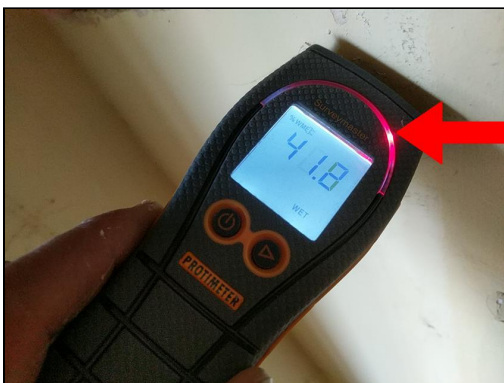
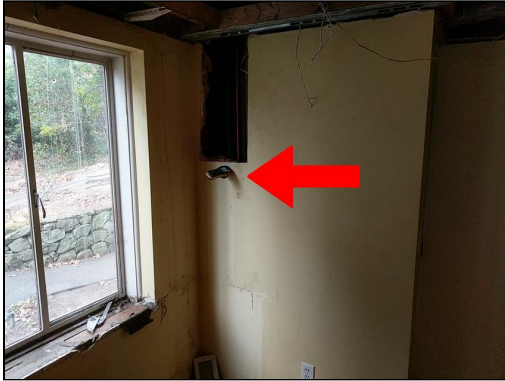
5.0.A (1) Elevated moisture was detected and what appeared to be microbial growth was visible on the walls in the downstairs bonus room. The type of growth or number of spores was not determined and would require specialized testing and laboratory analysis. The underlying cause is moisture. Recommend further analysis by a qualified mold remediation specialist and identifying and correcting the source of moisture intrusion by a qualified contractor.

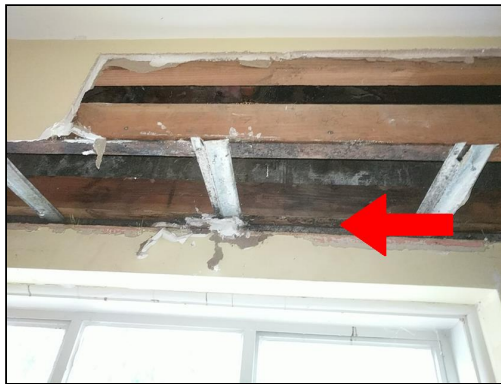
5.0.A (2) Exposed soffits had mold and wood rot visible. Recommend further evaluation and repairs as needed by a qualified contractor.

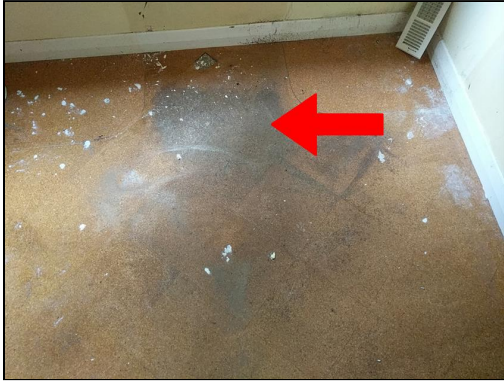
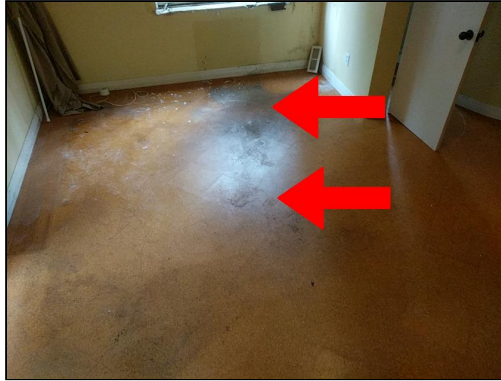
5.1.A Floors in the downstairs bonus room had extensive water damage from leakage. Recommend further evaluation and repairs or replacement as needed by a qualified contractor.
